# Uttarakhand tunnel collapse

Why is in news? Uttarakhand tunnel collapse: 'In building Himalayan tunnels, support and monitoring key', say experts

The under-construction Silkyara-Barkot tunnel on the Yamunotri National Highway in Uttarakhand's Uttarkashi district collapsed at dawn on November 12.

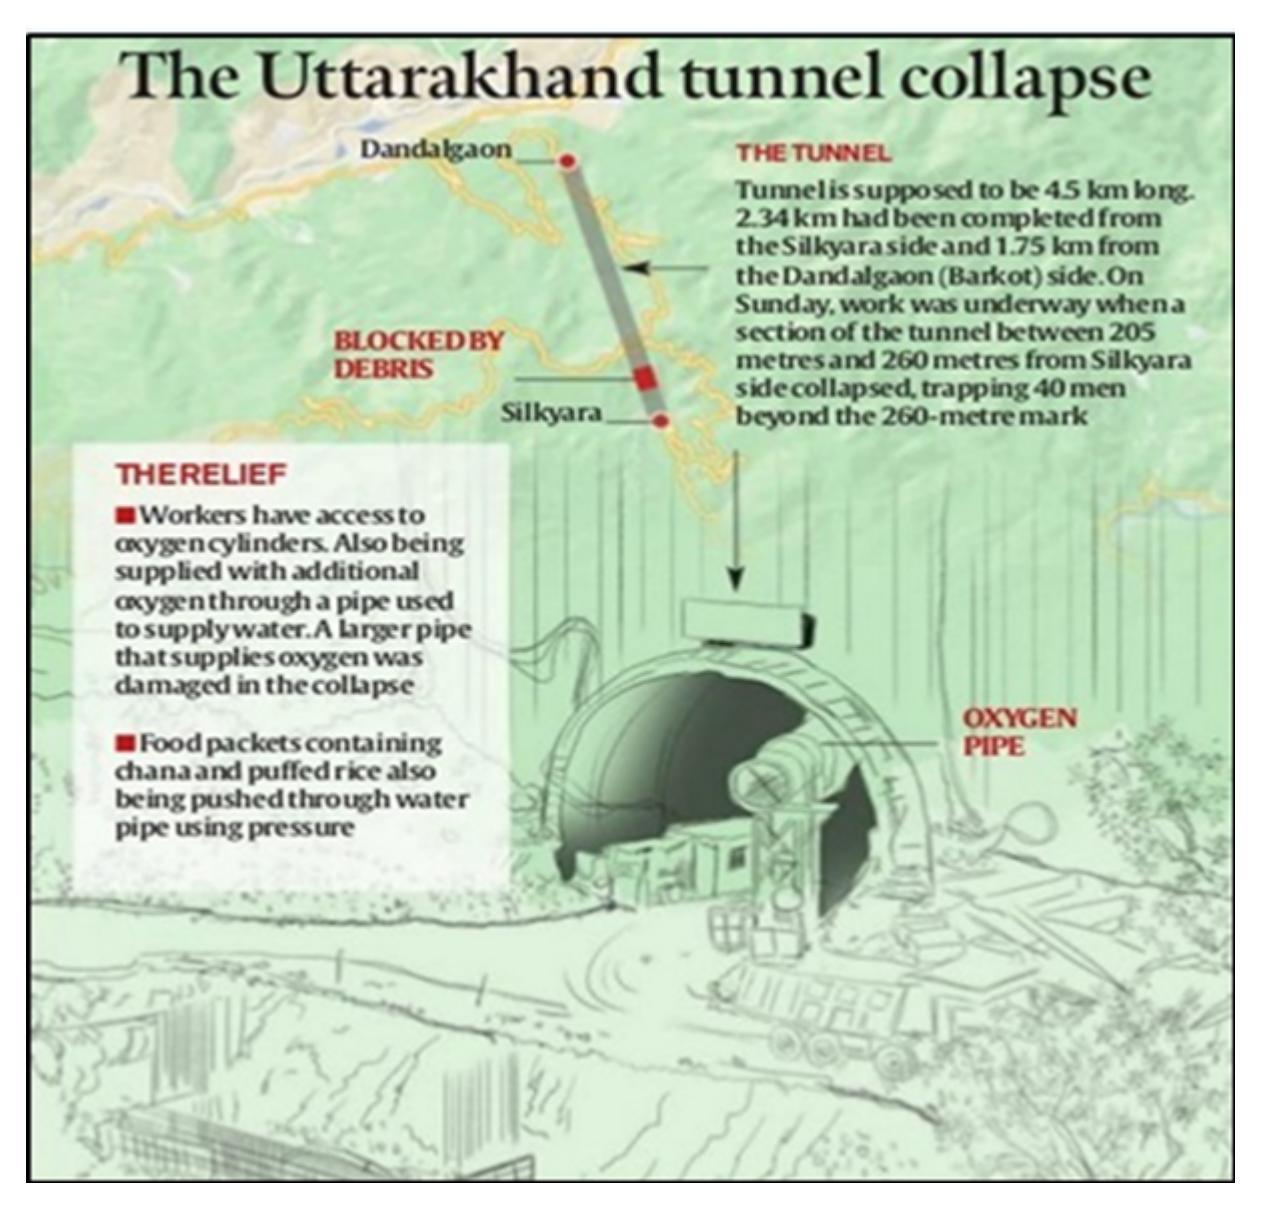
The **Border Roads Organisation (BRO) has created an access road** to, and built a platform at, the top of the hill where vertical drilling is set to take place

The **Border Roads Organisation (BRO) has created an access road** to, and built a platform at, the top of the hill where vertical drilling is set to take place.

RVNL has started work on a **six-inch-wide vertical pipeline** from this platform into the place where the workers are trapped. This pipe will work as another means by which supplies can be passed to them.

SJVNL will **drill a vertical tunnel** from the top of the hill to rescue the trapped labourers. Accordingly, equipment has been mobilised from Gujarat and Odisha with the help of the Railways. ONGC, which has expertise in deep drilling, has also taken part in the initial work of drilling the vertical tunnel.

The third part of the plan **involves horizontally drilling 483 metres** to reach the workers by creating a "micro" tunnel from the Barkot side. This will be undertaken by THDCL. Heavy machinery has already been mobilised and the work is expected to start soon.

The fourth part is the **strengthening of the existing tunnel**, and after working on safety arrangements, NHIDCL will continue to drill from the Silkyara end under the fifth part of the plan.
