Uttarakhand tunnel collapse

Why is in news? Uttarakhand tunnel collapse: 'In building Himalayan tunnels, support and monitoring key', say experts

The under-construction Silkyara-Barkot tunnel on the Yamunotri National Highway in Uttarakhand's Uttarkashi district collapsed at dawn on November 12.

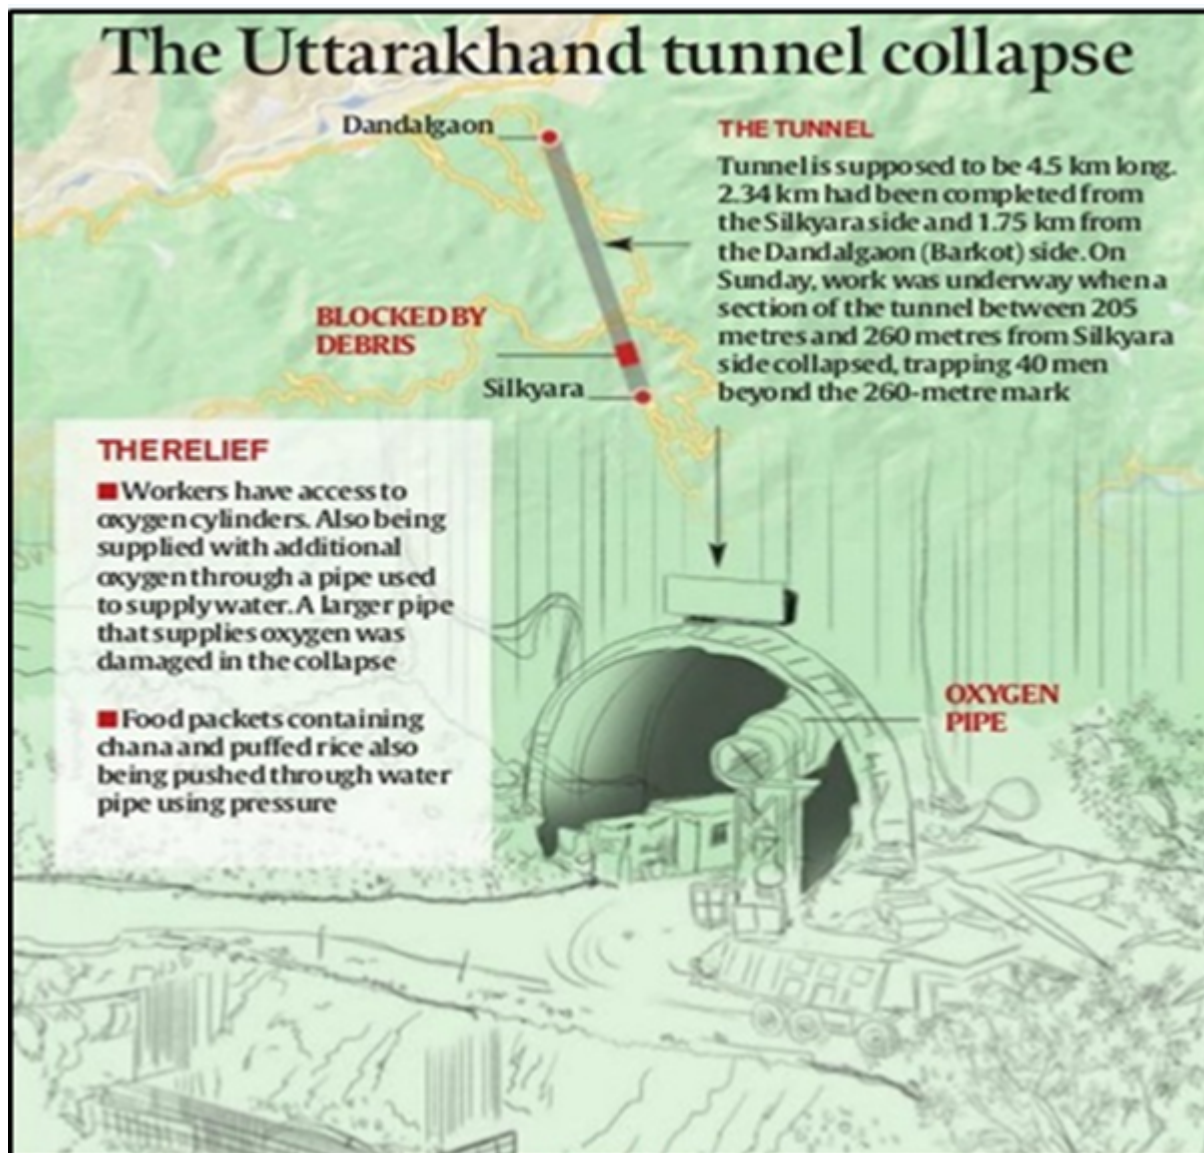
The **Border Roads Organisation (BRO)** has created an access road to, and built a platform at, the top of the hill where vertical drilling is set to take place.

RVNL has started work on a **six-inch-wide vertical pipeline** from this platform into the place where the workers are trapped. This pipe will work as another means by which supplies can be passed to them.

SJVNL will **drill a vertical tunnel** from the top of the hill to rescue the trapped labourers. Accordingly, equipment has been mobilised from Gujarat and Odisha with the help of the Railways. ONGC, which has expertise in deep drilling, has also taken part in the initial work of drilling the vertical tunnel.
